CASE STUDY

Huntington Theatre/Boston, MA

Historic Boston Theater is First Building To Include Thermally Broken Smoke Vent

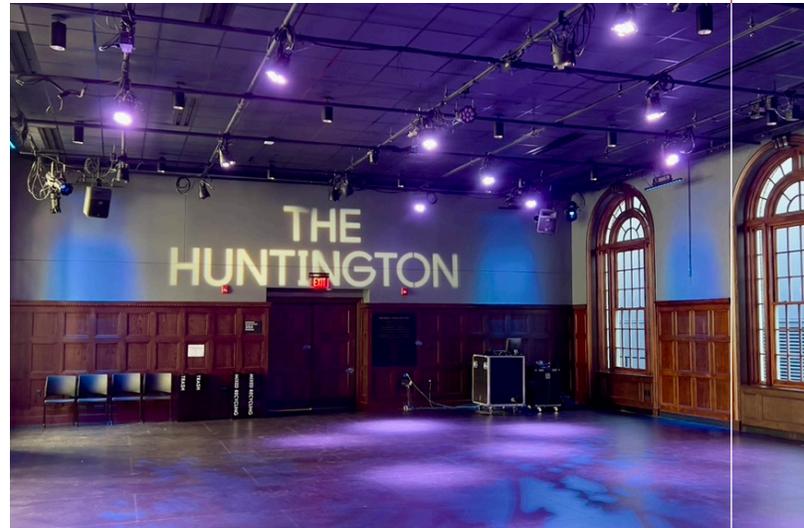
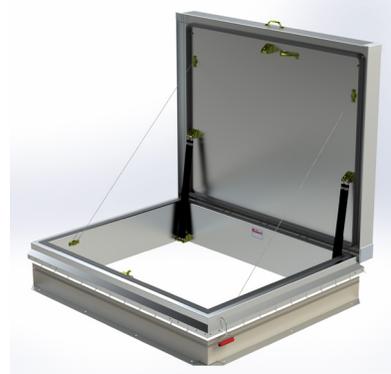
The smoke vent joins the company's thermally broken roof hatch in its line of superior energy efficiency products. The single-leaf smoke vent measures 4-feet, 0-inches x 4-feet, 0-inches and is designed with an element of low conductivity integrated between interior and exterior surfaces of the cover and frame to reduce temperature transfer. The thermally broken components also dampen vibration.

Three inches of polyisocyanurate insulation provide an R-value of 20-plus in both the cover and curb and a special cover gasket minimizes air leakage.

"The BILCO smoke vents were specified because they met all the project's needs," Zuker said. "The smoke vents are located

at the top of the flytower, directly above the theatre stage, and therefore needed to be quiet acoustically. In addition, the unit also had the correct size to provide the required ventilation above stage."

"Rather than attempt to replace the vertically positioned vents, the team abandoned the existing structure and looked for other options to ventilate the stage," Zuker said. "The BILCO smoke vent was specified as a solution as it was ready to install, could be integrated with the fire alarm, and was large enough to ventilate the entire stage appropriately."
